Inspection Report

1452 Via Merano Street Henderson NV 89052

Republic Home Inspections LLC

Date: 4/17/2024	Time: 03:00 PM	Report ID: 041724-104
Property:	Customer:	Real Estate Professional:
1452 Via Merano Street	Rick Ayala	Steve Thomas
Henderson NV 89052		The Thomas Group

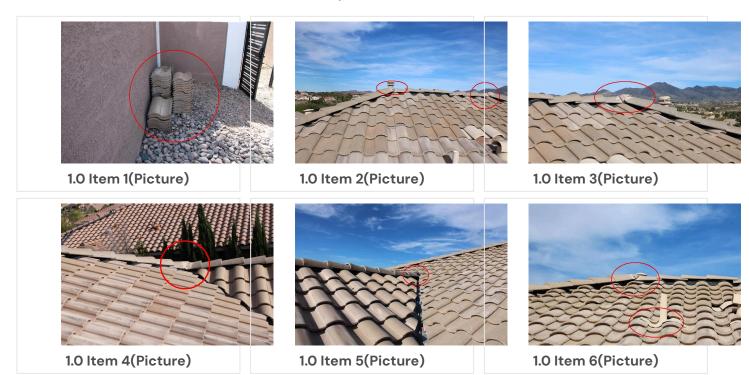
- 2. Damaged/missing/repaired/replaced roof tiles with signs of deterioration at the sealant at ridge tiles and flashing areas observed at various locations. It is difficult to determine if there are any active or passive leaks at roof areas. Recommend further evaluation of the entire roof and related components and have the appropriate repairs completed by a licensed roofing contractor to ensure water tightness of the building.

- 3. FYI: Due to several new concrete tiles that have been added to the roof and the evidence of what appears to be worn/defective concrete tiles. It is recommended you have a qualified licensed roofer further evaluate the entire overall condition of the concrete tiles/roof.

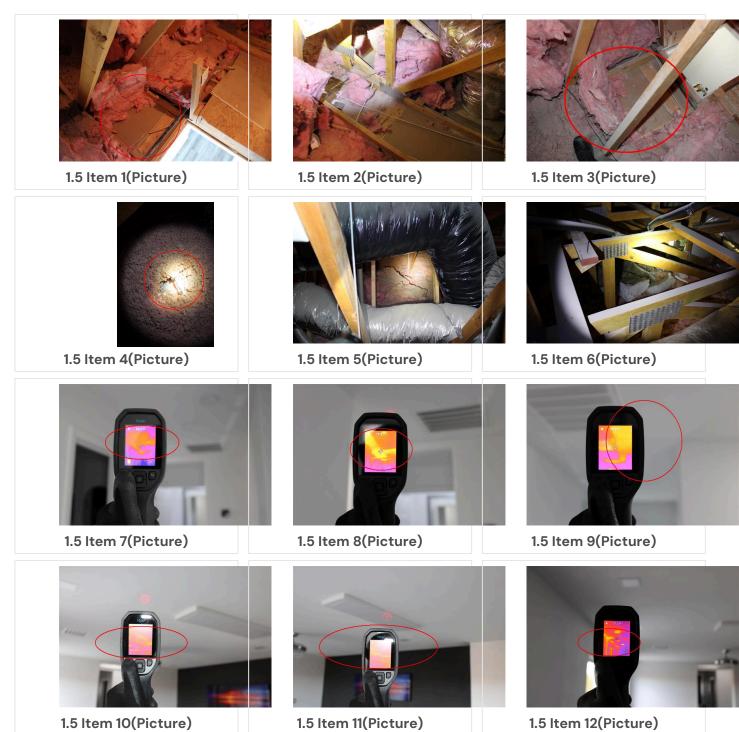
Insulation is displaced or missing, located in the attic area at several locations. Replace as needed for proper insulation resistance and in order to conserve energy. Recommend further evaluation and repairs/replacement by a licensed contractor at all needed locations.

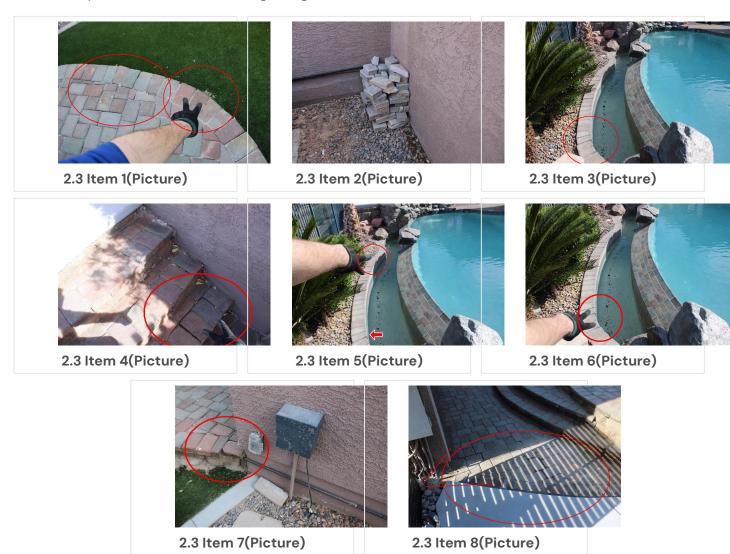
- Several concrete paver tiles in the backyard were uneven/displaced/settled/missing paver sand, etc, with a few loose paver tiles at the steps and edge sides areas of decking at various locations. Recommend further evaluation and repairs/proper corrections by a qualified licensed contractor at all needed locations for safety enhancements.
- 2. Negative slope of grading at the pavers next to barbecue. Extra soil materials may be needed under the pavers due to washed out grading at the underside areas of tiles.

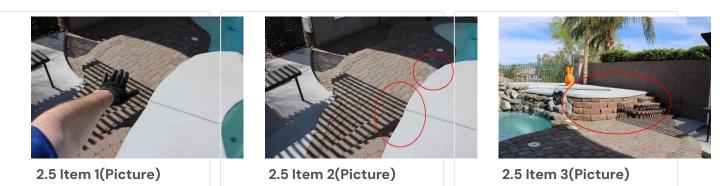
Missing railing at the pool/spa decking areas. Recommend further evaluation and repairs/proper corrections by a licensed contractor for safety enhancements.

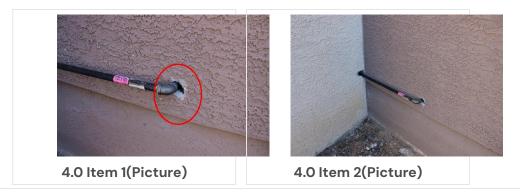
1452 Via Merano Street Page 15 of 58 Large opening at the exterior wall on the north side of property at added gas line. Corrections recommended.

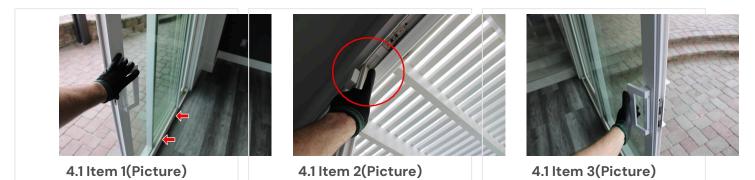
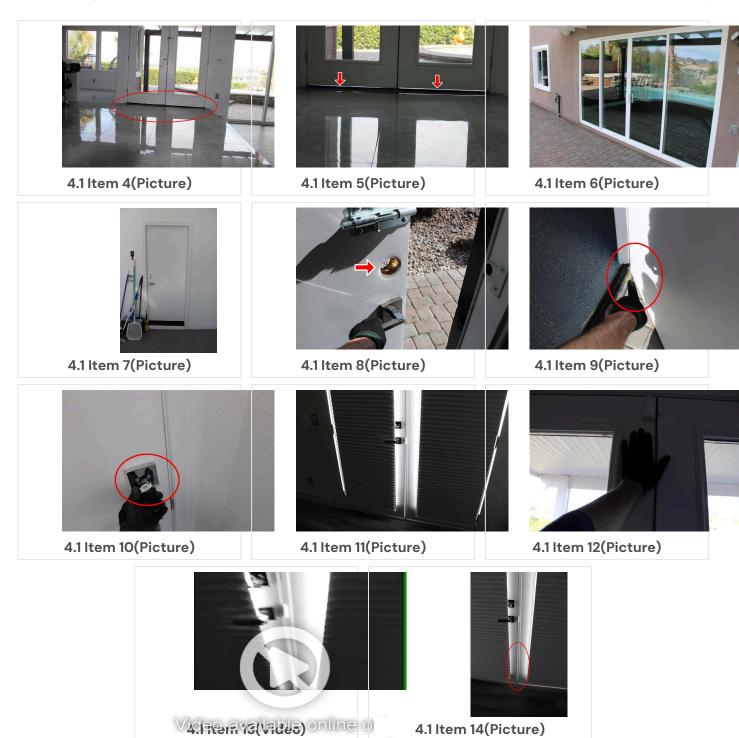
- 1. At the family room double sliding glass doors. Both doors were difficult to operate and in need of adjustments and repairs to function properly. Recommend further evaluation and repairs by a qualified licensed contractor to ensure both doors function properly.

- At the kitchen double exterior doors to patio in backyard. There was visible light at the bottom side of both doors. Recommend further evaluation and repairs/proper corrections by a licensed contractor.

- 3. Rear patio sliding screen doors were not present at time of inspection. Corrections recommended for safety enhancements.
- 4. The door from the garage to home is a fire rated/solid core door, and is required to be a self closing, self latching door. Dead bolt was difficult o operate. This door did not automatically, fully close and latch when tested. Recommend adjustment or repair for safety by using a licensed contractor.

- 5. Dead bolt missing a the south side garage exterior door. This door rubs on the threshold during operation. Recommend further evaluation and repairs by a licensed contractor.

- 6. At the upstairs front room that connects to balcony. The double exterior doors do not fully close, leaving visible light. Recommend further evaluation and repairs by a licensed contractor to ensure both of these doors fully close and seal.

- 7. Exterior doors to the balcony at the master bedroom are in need of adjustments and repairs to properly seal. Contractor recommended.

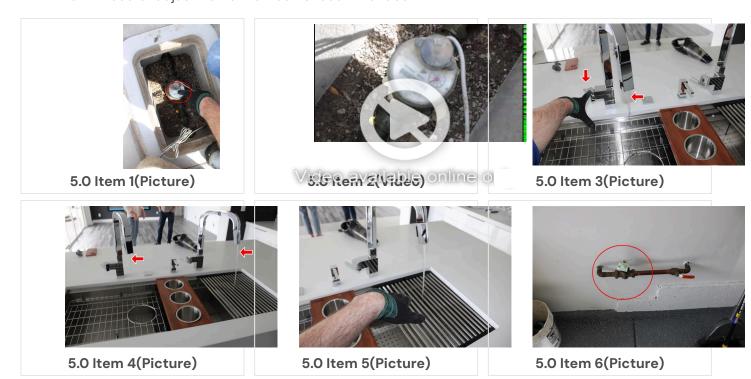
- 🗂 INSPECTED. REPAIR OR REPLACE
 - 1. The water flow indicator at the meter was in motion, this indicates water being used. The inspector was unable to locate the source of water in use. Recommend Inquiry with the Seller about any Past changes in water consumption. You will need to contact a licensed plumber for a possible solution.

2. FYI: Water pressure/volume was poor at a few locations during inspection. Inspector was unable to fully determine as to why this condition was present. Recommend further evaluation and repairs/ replacement/opinion by a qualified licensed plumber. FYI: Pressure regulator may be too small and or in need of adjustments. Plumber is recommended.

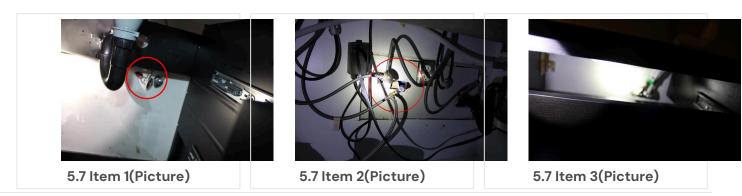
Plumbing water supply lines under sinks throughout this home appear to have been added. These lines were not properly supported, have openings around the pipes and drywall without covers around the pipe to wall areas. Corrections may be needed here. Check for building permits to ensure a licensed plumber installed all new added plumbing lines. Recommend further evaluation and repairs by a licensed plumber as needed at needed locations.

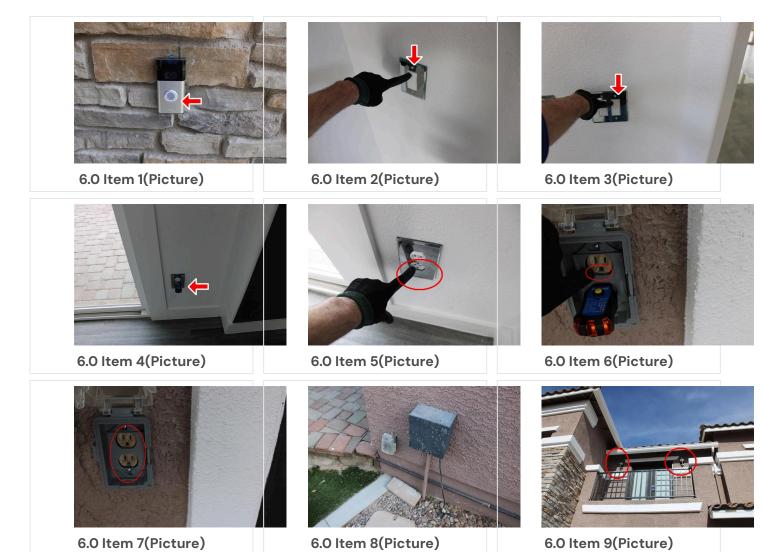
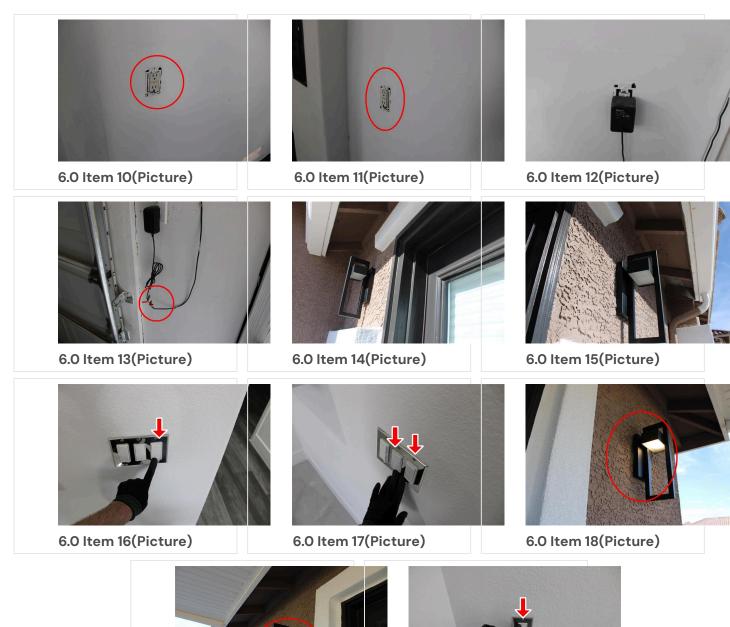
- 1. The door bell did not operate when tested at time of inspection. Recommend further evaluation and repairs/replacement by a qualified licensed contractor.

- 3. Receptacle at the family room interior wall next to the sliding glass door was non functional at the bottom side outlet. Recommend further evaluation and repairs by a licensed electrician.

- 4. At the back porch exterior wall. The receptacle was not flush with the cover and top side outlet was broken. Electrician recommended.
- 5. Corrections suggested at the exterior yard light fixtures throughout exterior ground areas. These systems were unplugged and non functional when tested at time of inspection.

- 6. Light fixtures at the exterior walls had missing caulking. Corrections recommended for safety enhancements.
- 7. Missing cover plates at a few of the receptacles in garage. Corrections recommended.

- 8. Cord in garage that was plugged into outlet was improperly wired. Correct for safety.
- 9. Switches at the master bedroom interior wall were not flush with the cover.

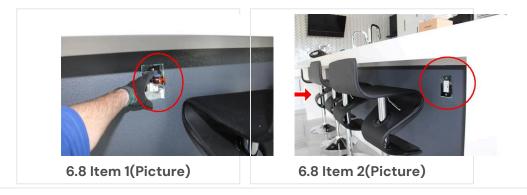
Receptacles at the kitchen island next to bar seats were not GFCI protected. Recommend further evaluation and repairs by a licensed electrician for safety enhancements.

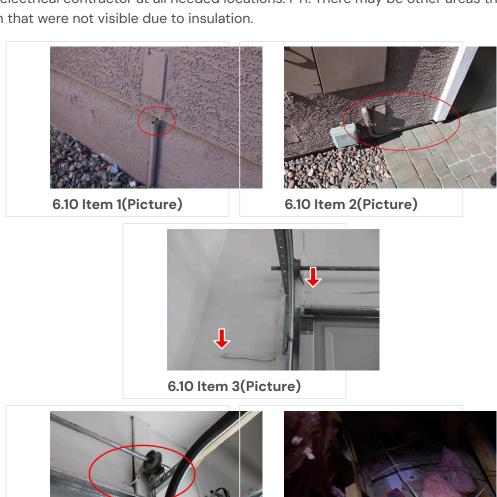
- 1. Improper wiring was observed, (wiring not properly enclosed in a approved casing or conduit), located at the north side exterior wall to grounds. Check for building permits. Recommend further evaluation and repair by a licensed electrical contractor.
- 2. Added electrical circuits were observed, however the inspector is unable to determine if this was

an appropriate installation. Located at the exterior wall directly under the main electrical panel, to grounds of this property. Check for building permits. Recommend further evaluation by a licensed electrical contractor.

- 3. Improper wiring was observed, (wiring not properly enclosed in a approved casing or conduit), located in the garage at interior wall to exterior light fixtures. Recommend further evaluation and repair by a licensed electrical contractor.
- 4. Improper wiring was observed, (wiring not properly enclosed in a approved casing or conduit), located in the attic space at various locations. Recommend further evaluation and repair by a licensed electrical contractor at all needed locations. FYI: There may be other areas that have this condition that were not visible due to insulation.

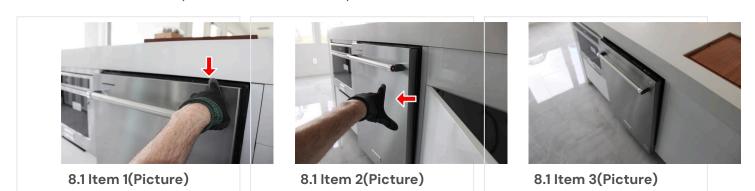
- 1. The dishwasher was loose and not attached to the countertop properly. Recommend further evaluation and repairs by a licensed contractor.
- 2. Dishwasher was non functional at the time of inspection. Recommend further evaluation and repairs by a licensed appliance technician. This unit did not appear to be getting water during operation. This condition may be due to low/no water pressure issue. Plumber recommended.

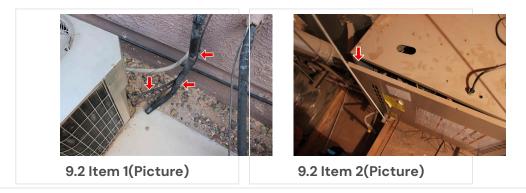
- 1. Insulation is missing or damaged around the outdoor A/C condensing units refrigerant lines. Recommend insulating these lines in order to aid in the proper operation and efficiency of these unit(s).
- 2. Cover at the south side HVAC unit in the attic was loose or not properly installed. Corrections recommended.

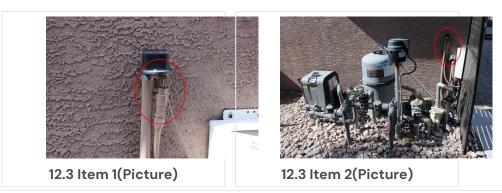
The conduit connection is loose, located at the pool/spa electrical component at the south side exterior wall to the left of control panel. Recommend that a licensed pool technician further evaluate the electrical components/equipment and make the appropriate repairs.

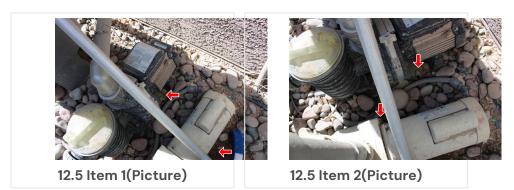
- FYI: Both of the pump/motor's were not properly secured down to solid platform at the time of inspection. Recommend further evaluation and repairs by a licensed pool contractor for safety enhancements.
- 2. The conduit connection is loose, located at the pump motor. Recommend that a licensed pool technician evaluate the equipment and make the appropriate repairs.

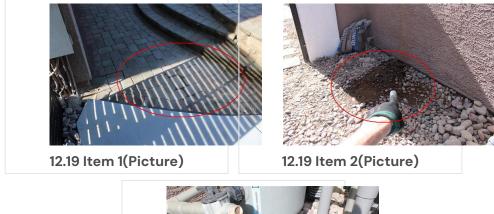
FYI: Solar systems have been removed from the pool/spa equipment at the exterior wall. The old pipes in the grounds that use to operate these systems were still present/connected and were not properly removed or capped off. If the valves at the equipment are turned to the on position, to the old solar systems, then pool water will bubble up from the grounds, at the left side of pool/spa heater and at the backyard concrete paver tile decking areas next to barbecue. Recommend a complete systems evaluation and repairs, proper corrections, removal of all old solar systems/pipes that are currently connected to pool/spa equipment by a licensed pool contractor.
